MISSOURI POWER AND LIGHT DAM

AUDRAIN COUNTY, MISSOURI

MO 10065

PHASE I INSPECTION REPORT
NATIONAL DAM SAFETY PROGRAM

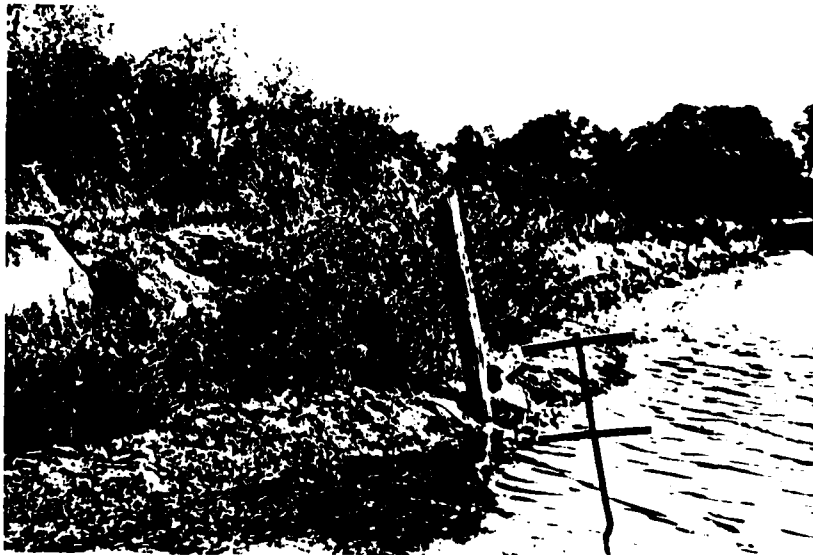
Photo 2 - View along upstream slope of embankment taken at left abutment of dam.

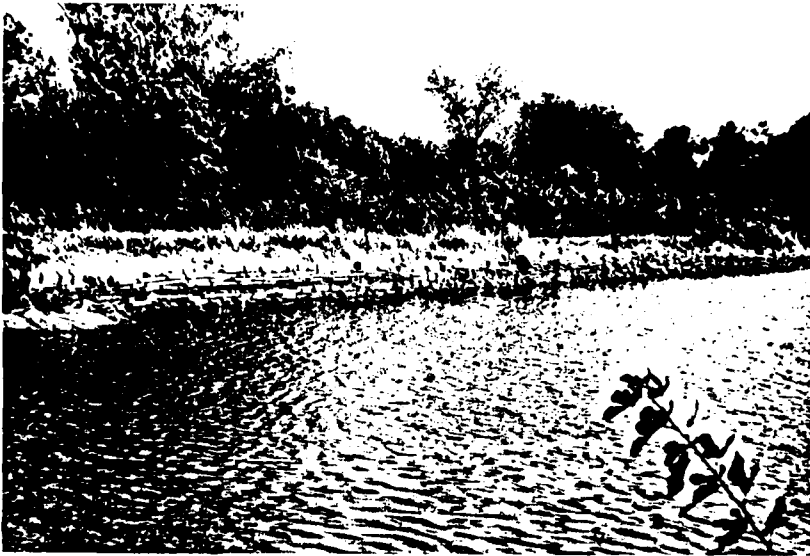
The crest of the dam is adequately protected by a heavy vegetative cover. The upstream slope of the embankment is in deteriorated condition. The wall constructed of loose blocks of used concrete and rocks is unstable in many places, appearing to be on the verge of failing into the reservoir. Cracking, indicating movement, can be seen behind the wall in several areas. Extensive rodent activity is occurring on the upstream slope and crest. Several large holes could be seen which are likely occupied by muskrats. Shells of fresh water

Photo 3 - Picture of typical section of upstream embankment slope near left side of dam.

4. Clear large trees and brush from the downstream embankment slope, and prevent future growth by frequent maintenance.
5. Make repairs, as necessary, to the upstream slope, including strengthening areas currently exhibiting instability.

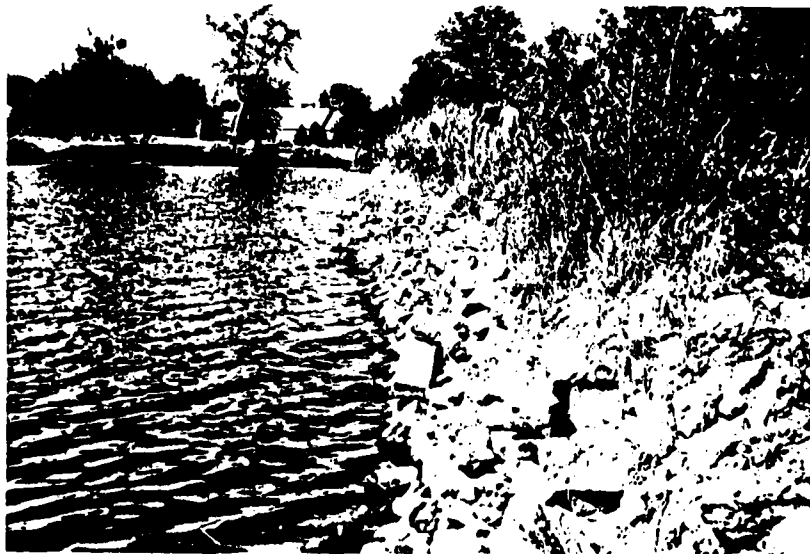
Photo 4 - Picture of upstream embankment slope taken on upstream slope near center of dam.

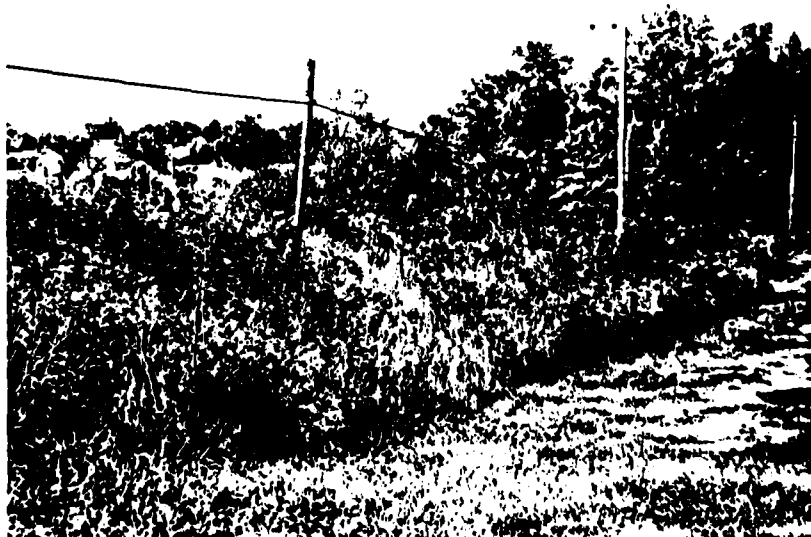
The downstream slope of the embankment is also in deteriorated condition. Heavy brush and tree growth is present on the slope. The heavy vegetation made it difficult to inspect the embankment slope, but several areas were moist and contained vegetation indicating potential seepage. The slope itself is very steep, and sloughing was prevalent. The slope is generally uneven and irregular.

Photo 8 - Picture of downstream embankment slope taken downstream of dam near right abutment.

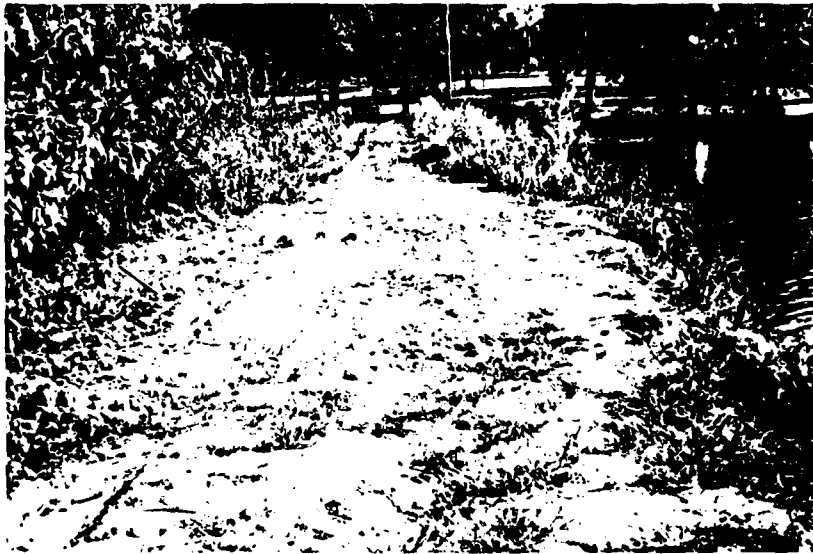
One section of the embankment has been recently repaired, located approximately 125 feet from the right abutment. A leak had developed on the downstream embankment slope, and attempts to repair the leak by addition of material to the upstream embankment slope proved unsuccessful. The reservoir was then lowered several feet, and a section of embankment 4-feet wide by 8 to 10-feet deep was excavated. The excavated section was then replaced with a mixture of nearby clay and "fireclay". A representative of the owner indicated that compaction was achieved with the bucket of the backhoe, and visual inspection did not reveal the compaction to be satisfactory.

The repaired section of embankment is of questionable stability. The compaction of the earthfill is likely not satisfactory, based on visual observation and the reported method of compaction. The section was also replaced with a steep slope corresponding to the remainder of the embankment. A rodent hole was reported to be the cause for the leak which initiated the repairs. Rodent activity is prevalent on the embankment.

Photo 9 - Picture of repaired section of embankment as seen on the dam crest.

A comprehensive stability study of the embankment section is recommended. This study should include determination of the embankment cross-section by survey, drilling of test holes into the embankment and foundation to provide information about the embankment and foundation condition and, possibly, the installation of piezometers to locate the phreatic line for the embankment section. The study should also analyze the recently repaired section of embankment in detail, with recommendations.

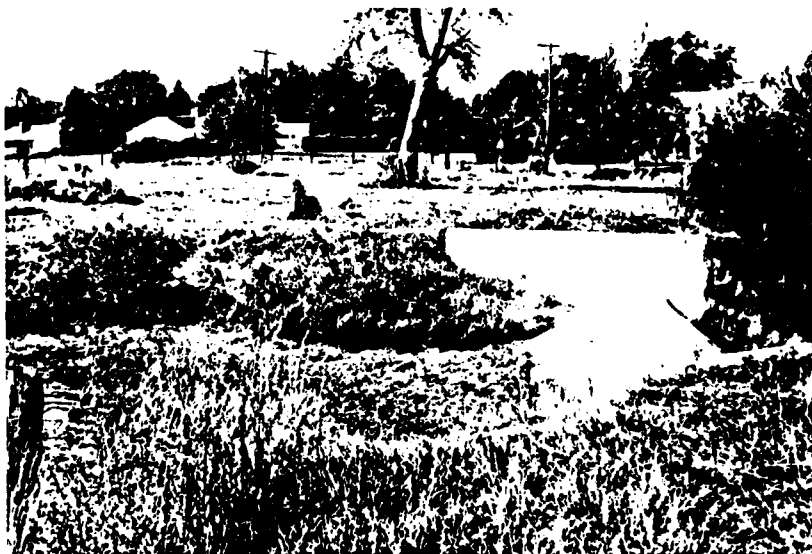
Photo 11 - Picture of spillway approach channel taken from dam crest.

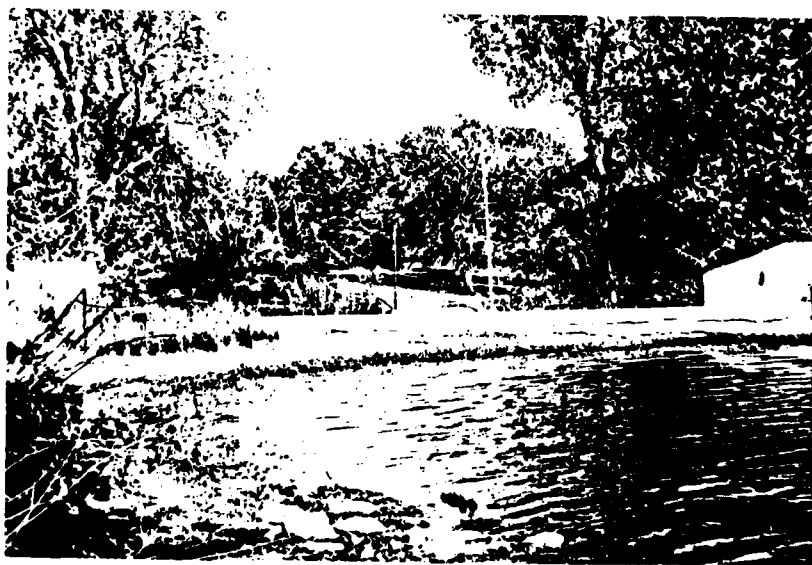
Photo 12 - Picture of entrance to spillway taken from left abutment of dam.

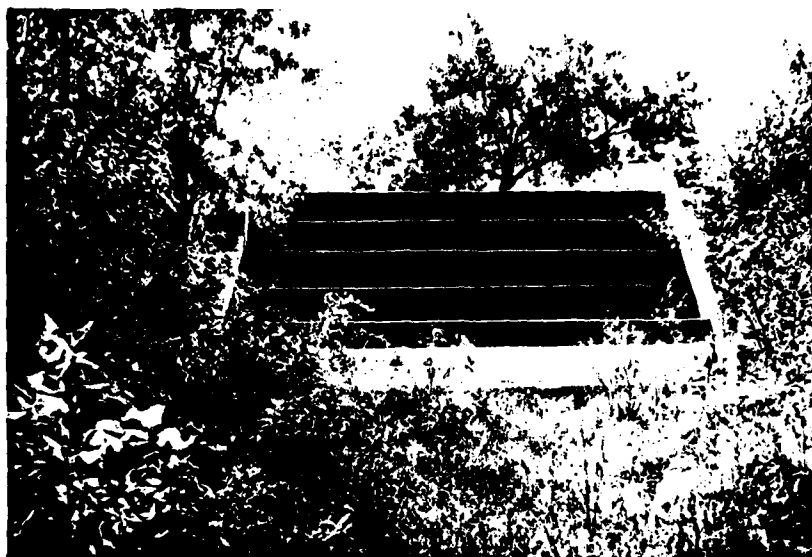
The concrete in the spillway structure is in deteriorated condition. Heavy vegetative growth was noted on the left side of the approach channel. Erosion, spalling, and cracks in concrete were noted in the structure. The downstream channel is obstructed by fallen tree trunks and debris, and the channel banks show signs of erosion and sloughing.

Photo 13 - Picture of spillway taken from downstream.

6. Eliminate rodents currently burrowing into the embankment, and fill holes with compacted earthfill to the extent possible.
7. Make repairs to the deteriorated concrete in the spillway structure and stabilize the downstream channel slopes.
